# Housing

### ***Housing Condition Analysis***

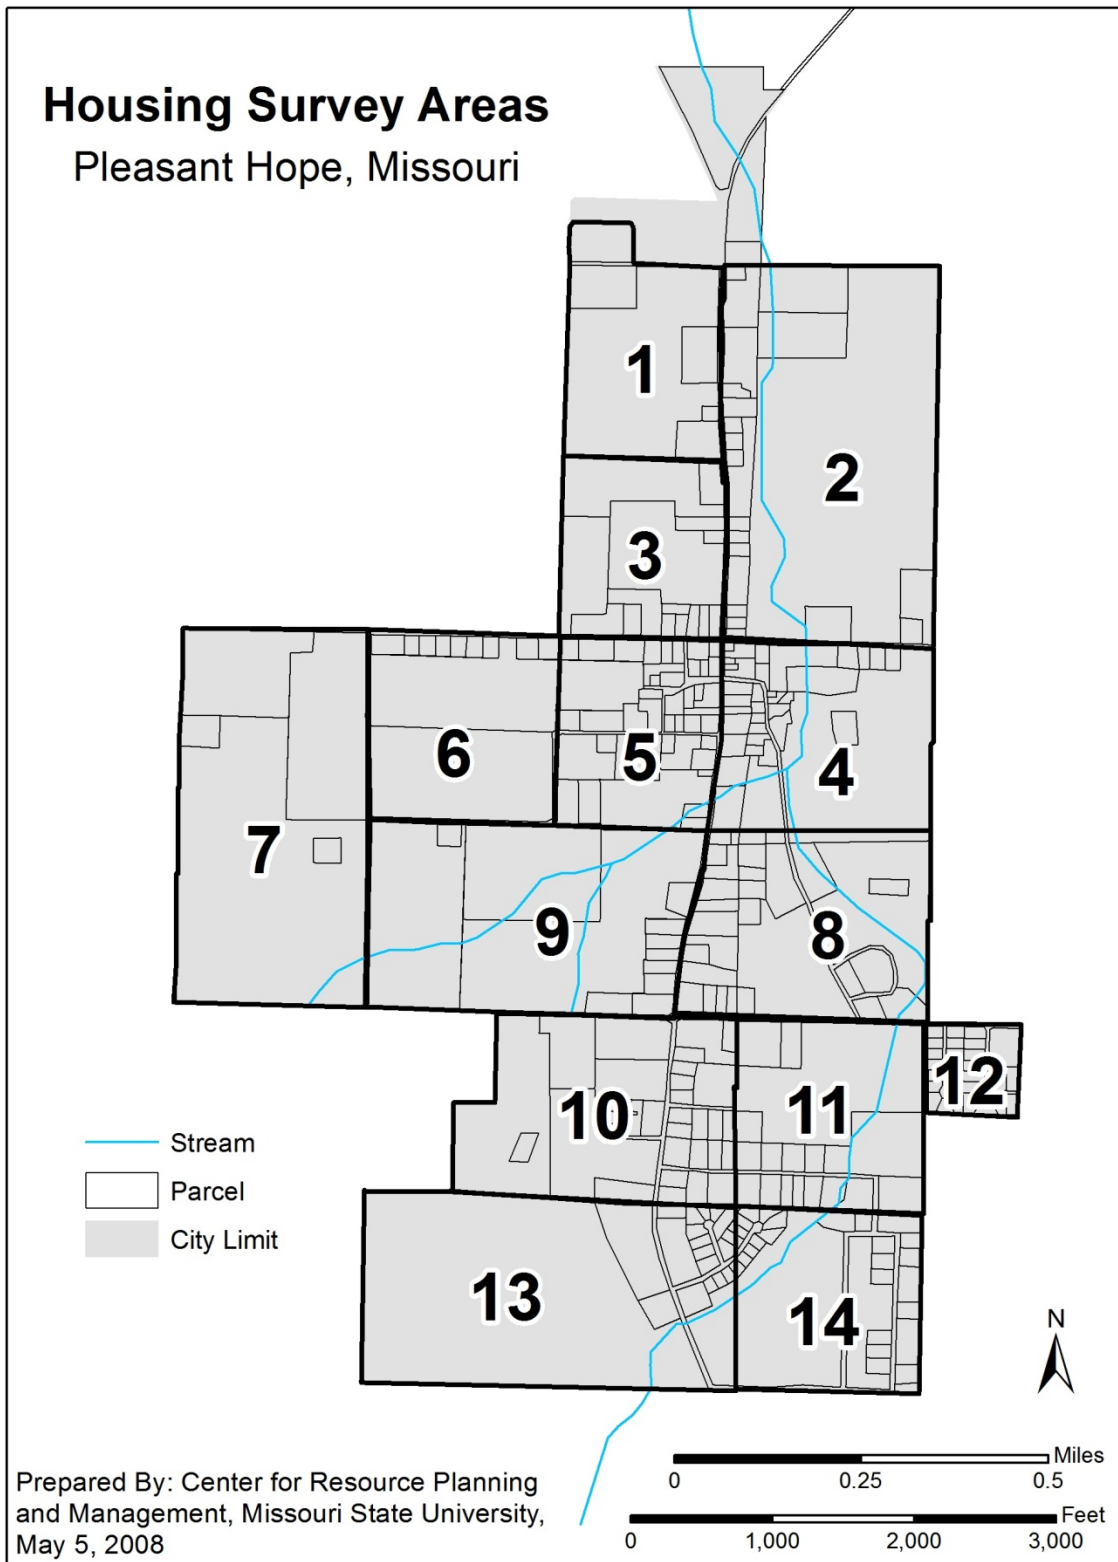
Figure 4-1: Housing Survey Areas

The city was divided into 14 survey block areas which are displayed in Figure 4-1. The summary results of the housing conditions survey are presented in Table 4-4. A total of 215 housing units were evaluated and of these units, 72 percent were ranked in the Standard category and 15.8 percent of units were ranked as in need of Minor Repair. Housing units ranked as Substandard or in need of major repair accounted for 8.3 percent of total units surveyed while 8 housing units (3.7%) were considered to be in dilapidated condition and not economically viable for rehabilitation.
